SERVICE COMPLETION REPORT

Report Number: SV-VKS-001

SERVICE DESCRIPTION: **Overhaul of Cooling water pumps and Anticorrosion coating**

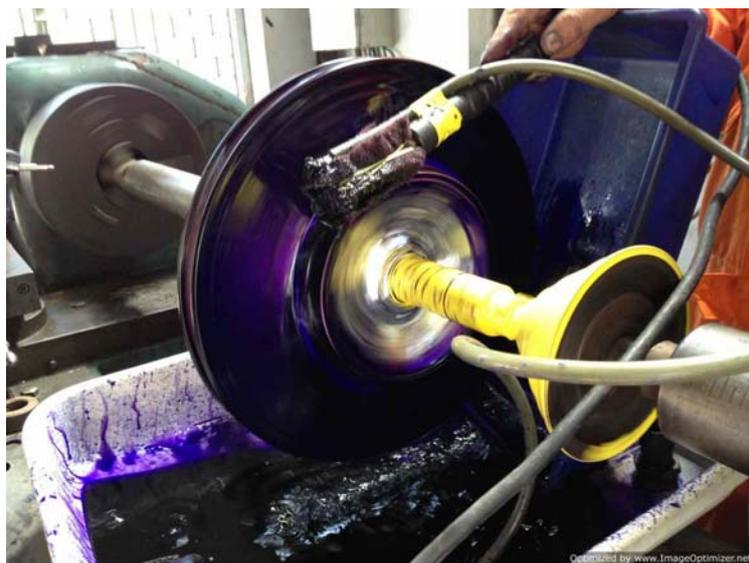
Fill up lost material at impeller wearing ring by Electroplating Technology

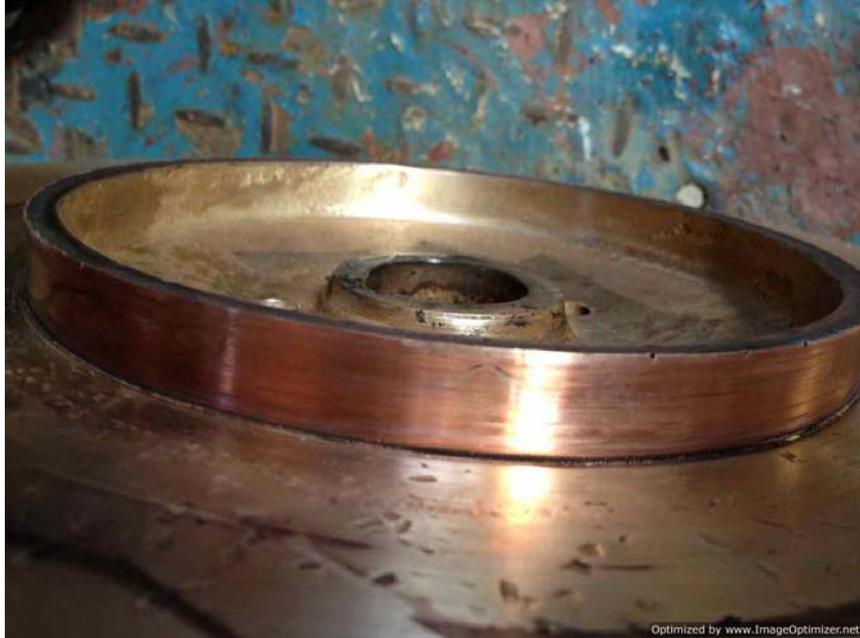
The impeller wearing ring after repaired

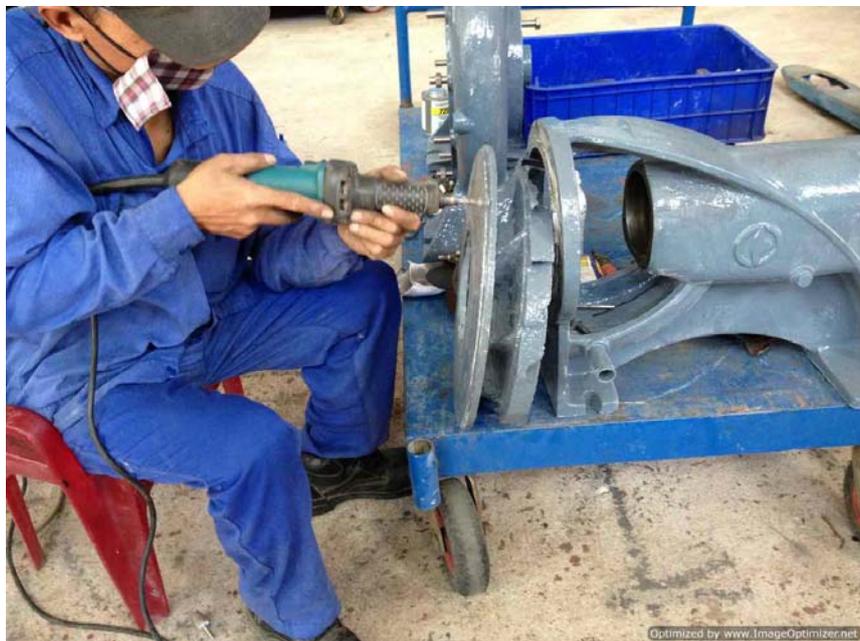
Repairing of the pump after coating ARC

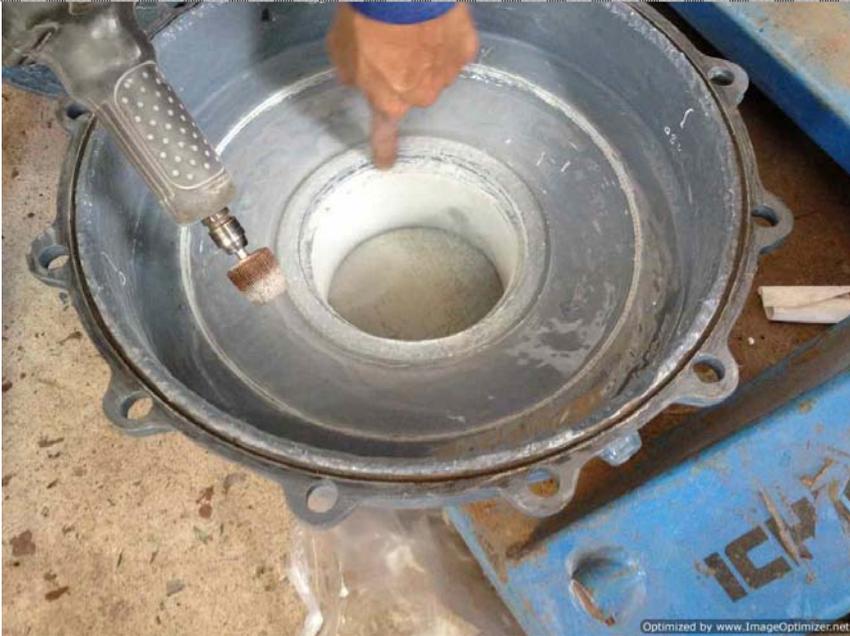
Pump casing repairing

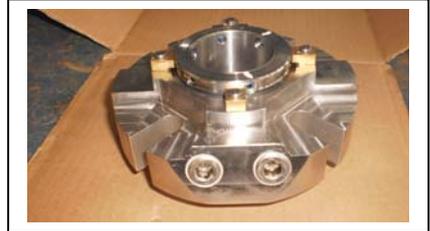
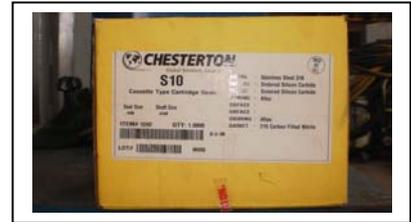
Mechanical Seal S10-Chesterton

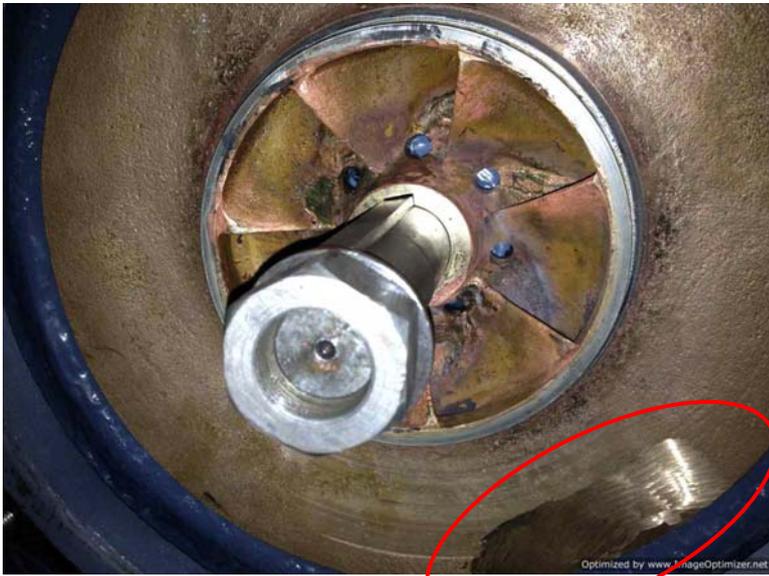
No.	Task Description	Result & Notes
1	Check and remove the pump. Dismantle the pump components.	- No highlight.
2	Pump components inspection and checking.	- The pump casing, impeller, stuffing box were found heavy corrosion and lost material at some positions. - The wearing ring of impeller as found worn-out at whole circumference of the ring. The gap of the wearing rings is > 2.5mm. - The impeller was found with many cracks at the root of the blades and shaft bore hole. - The gland packing bore hole was found heavy corroded, depth about 3mm at whole circumference of the part.
3	Repair the Impeller	- Repair the cracks at the impeller blades and shaft bore hole by welding. After welding completed, it was machined to get back its dimension. - Repair the worn-out wearing ring by Nickel and Chrome electroplating technology to fill up the lost material to get correct gap of the rings.
4	Dynamic balancing the impeller after repaired.	- After repaired, the impeller was checked dynamic balancing and found unbalance 65gram at unbalance

<p><i>angle 245o. Remove the unbalance material.</i></p> <ul style="list-style-type: none">- <i>The final parameter of balancing was accepted at 1.1gram at angle 232o.</i>
5	<p><i>Repair the stuffing box - gland packing bore hole.</i></p>	<ul style="list-style-type: none">- <i>The corroded bore hole of gland packing was repaired and rebuilt by ARC Coating.</i>- <i>Repaired other parts of stuffing box.</i>- <i>Modified to upgrade the gland packing into mechanical seal Chesterton type S10 size 45mm with successfully..</i>
6	<p><i>Pump casing repairing</i></p>	<ul style="list-style-type: none">- <i>Cleaned and removed all corroded parts of the pump casing.</i>- <i>Coating entire the pump casing by ARC 855 and SD4i.</i>
7	<p><i>Commissioning – leak test.</i></p>	<ul style="list-style-type: none">- <i>The pump was reassembled after repaired and done water pressure test with 8bar to confirm the repaired job completion.</i>

Impeller balancing

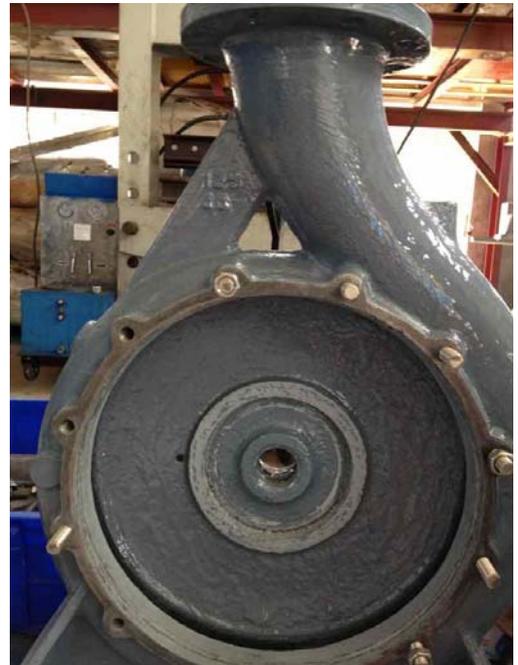
Pump casing after Coating ARC

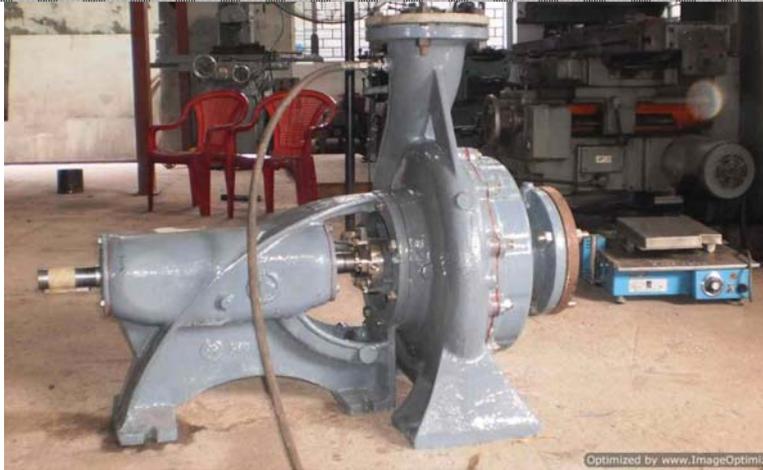
Pressure test after repaired at 8bar
